# *Juneau Airport Wind System (JAWS) Wind Sensor Severe Weather Performance Test Report*

August 2002

DOT/FAA/CT-TN02/18

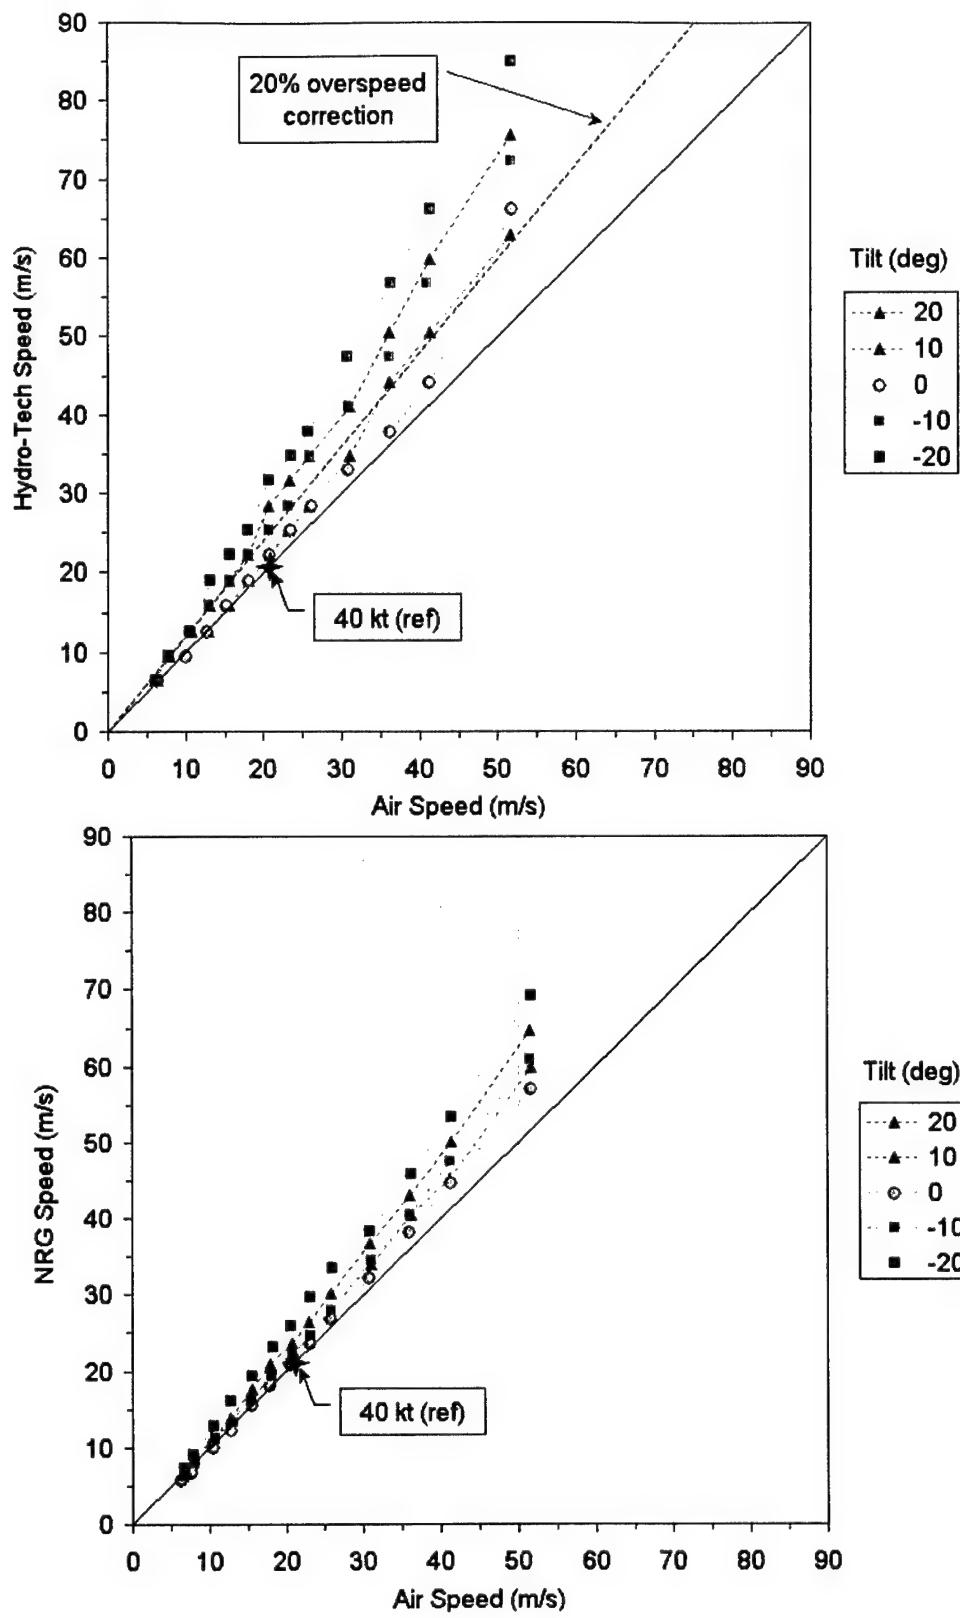
FIGURE 27. WIND TUNNEL ACCURACY RESULTS FOR HYDRO-TECH AND NRG WIND SENSORS

Results of the accuracy tests for the two mechanical sensors are shown in figure 27. The figures show the sensor data plotted against the wind tunnel airspeed for the various tilt angles. The solid diagonal line indicates perfect agreement. For reference, the 20% overspeed correction factor applied to the Hydro-Tech anemometer data (see section 3.2.2.2.1.1) is also indicated in the figure. As previously mentioned, negative tilt angles indicate a wind from beneath the sensor (i.e., sensor tilted from the vertical away from the wind flow). Since the raw wind data was plotted in units of m/s, a wind speed of 40 kt is indicated in the figures for reference.

The results show that both mechanical sensors overestimate wind speed, and the degree of overestimation increases with increasing tunnel wind speed. The Hydro-Tech anemometer errors are greater than the NRG errors. Off-axis winds affect both sensors, with the effects more pronounced for the Hydro-Tech sensor. This observation is consistent with prior wind tunnel test data provided by the manufacturer. The Hydro-Tech data indicates that the 20% overspeed correction factor currently used in the Juneau wind system may be an underestimate. Based on wind tunnel air speeds at 40 kt, the Hydro-Tech sensor overestimates the wind speed by as much as 45% for an upslope wind 20° from the horizontal.

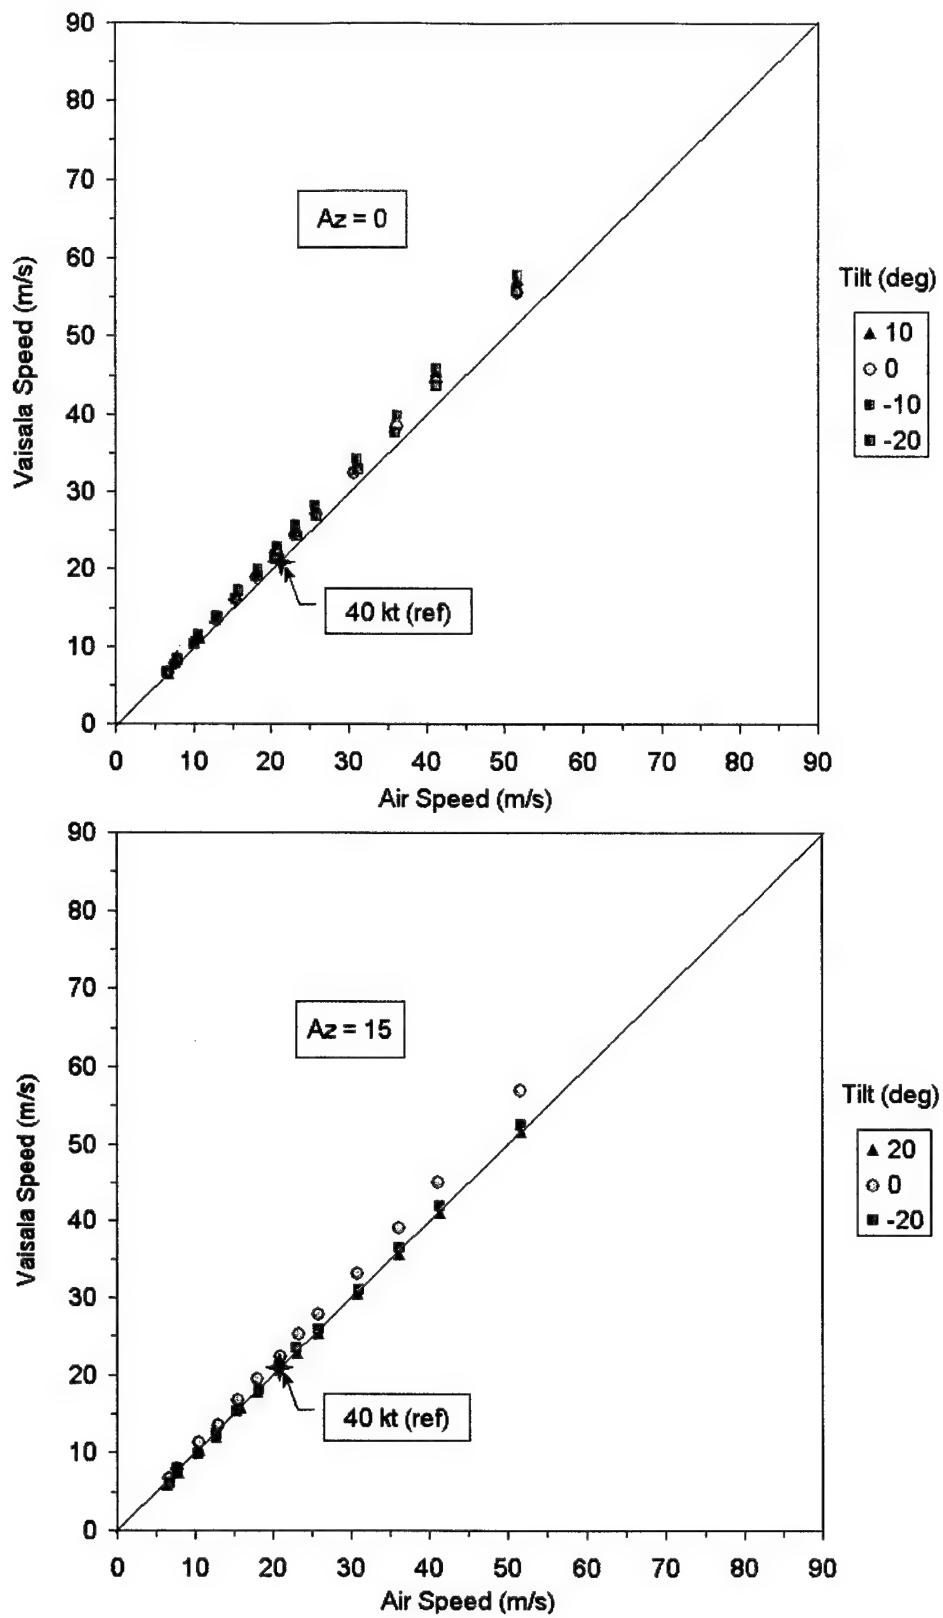
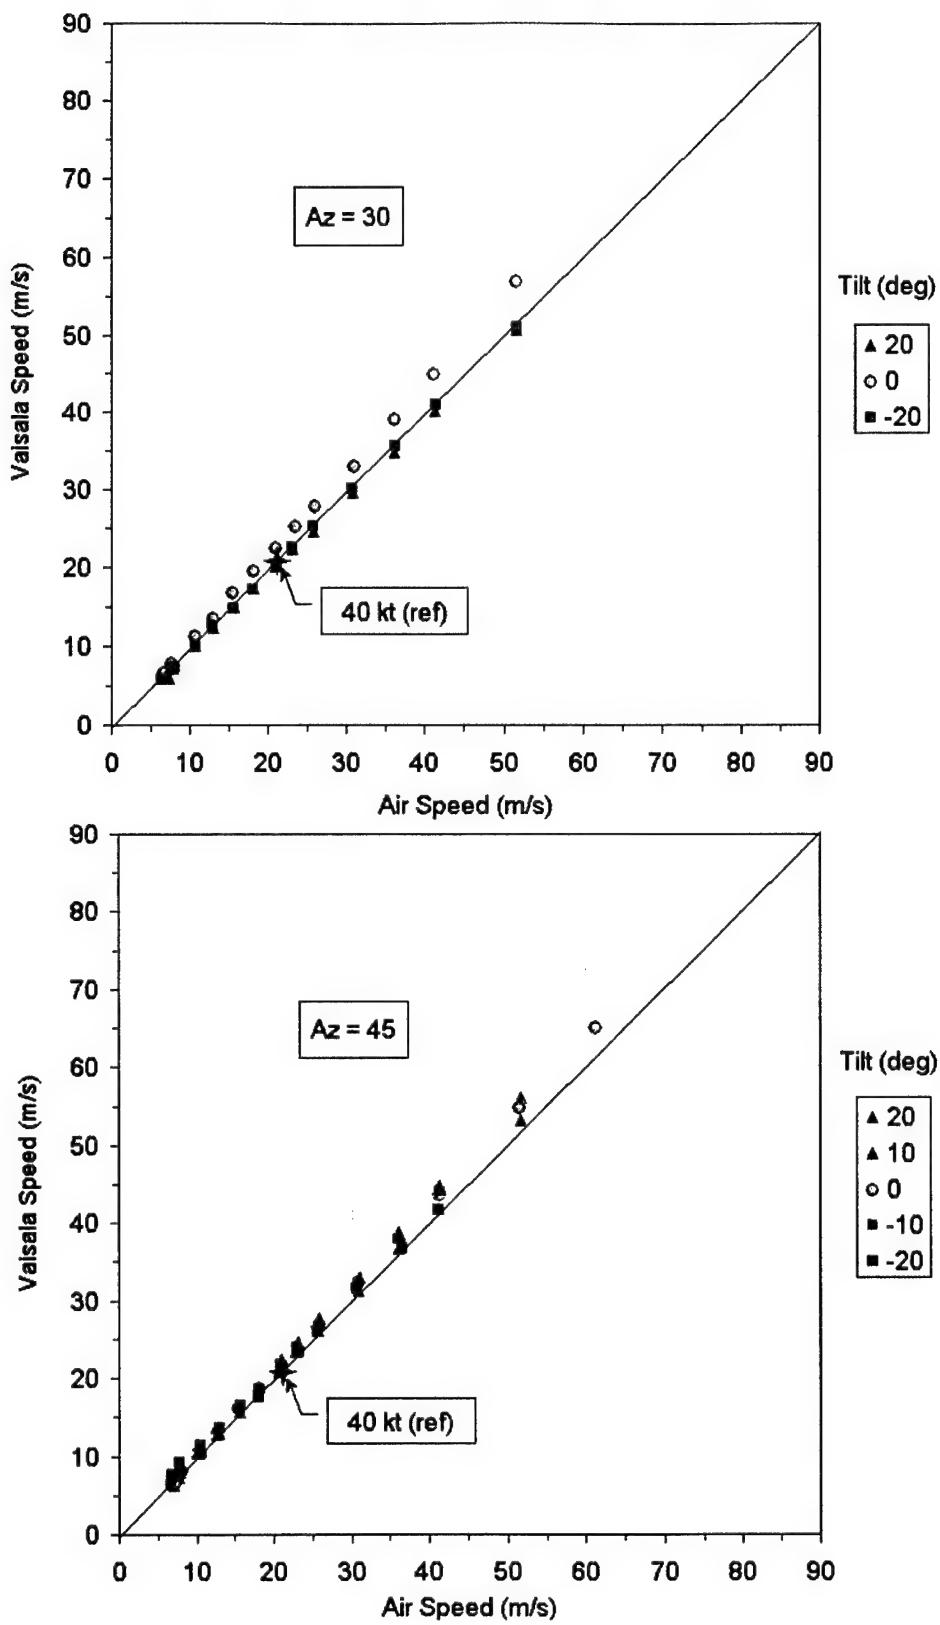
Accuracy results for the Vaisala anemometer according to the various tilts and azimuth orientations are shown in figures 28 and 29.

These results indicate that the Vaisala sensor provides better overall agreement than the mechanical sensors.

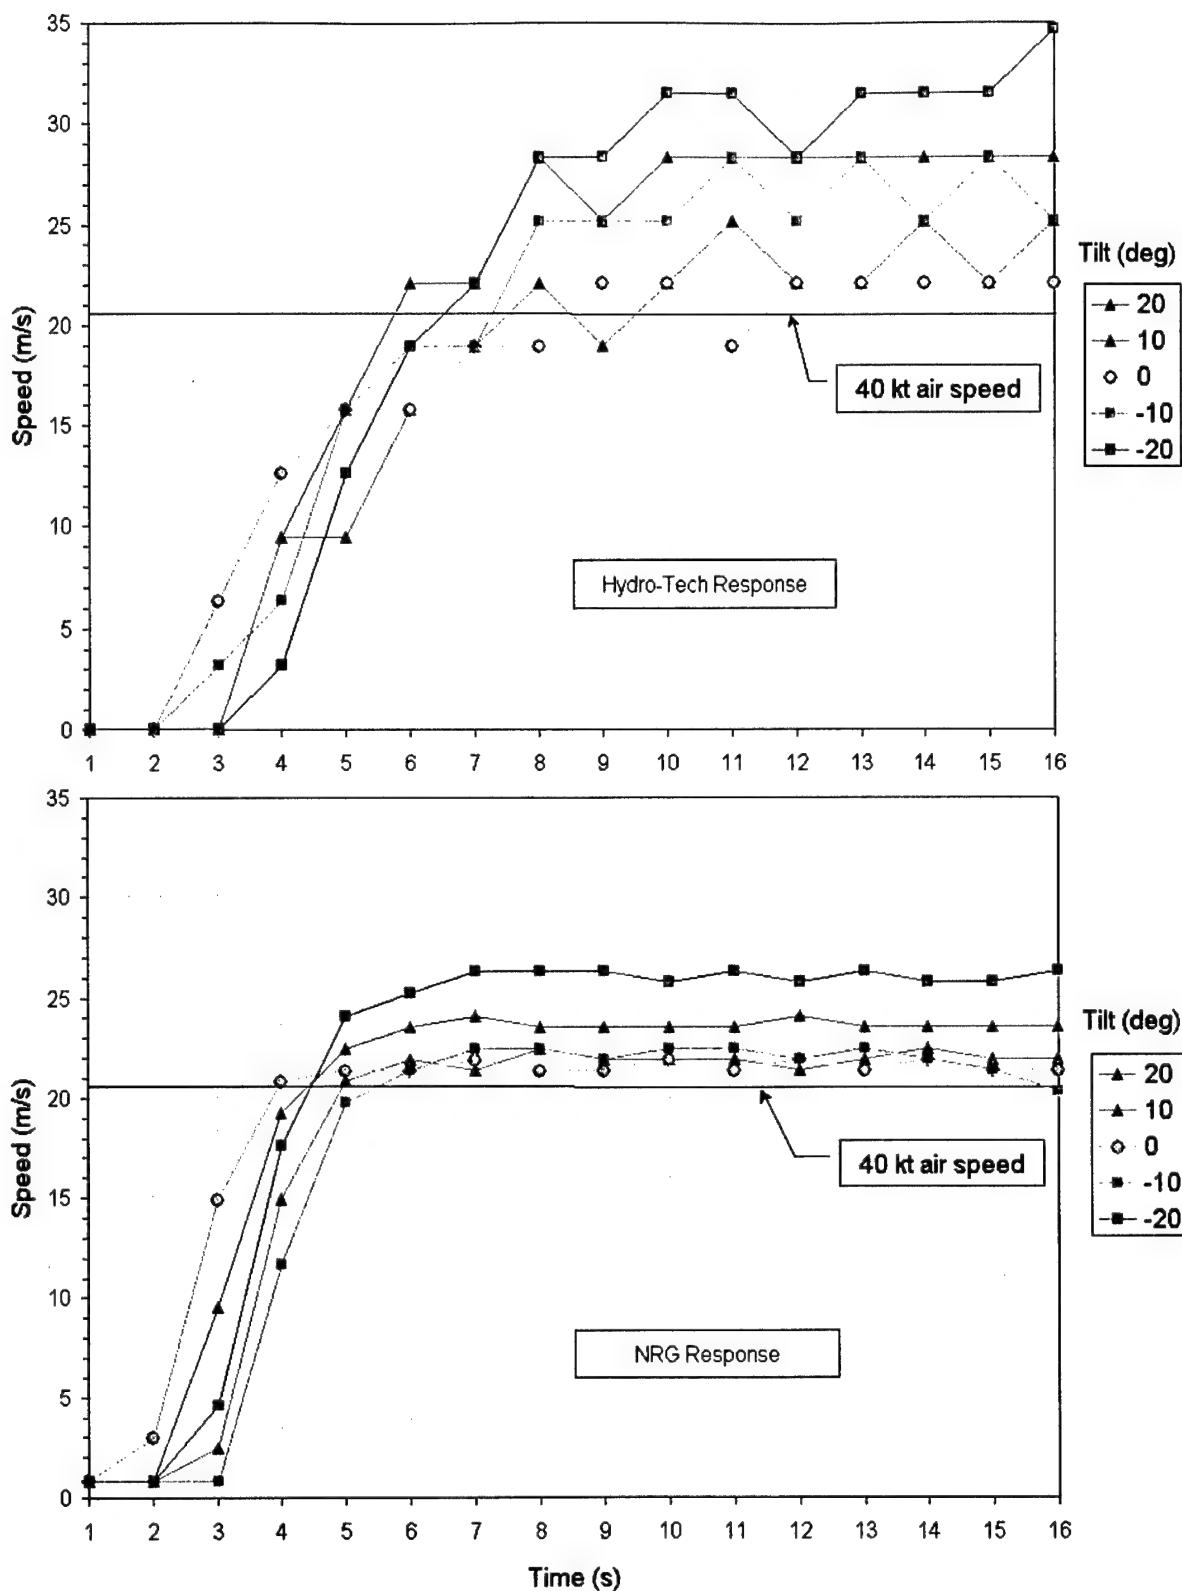
FIGURE 30. WIND TUNNEL RESULTS OF DYNAMIC RESPONSE FOR HYDRO-TECH AND NRG WIND SENSORS

The dynamic response characteristics of the mechanical anemometers are shown in figure 30. The figures show, as expected, that the NRG sensor is more responsive than the more massive Hydro-Tech anemometer. The figures also show the overspeeding that was presented in the previous section.

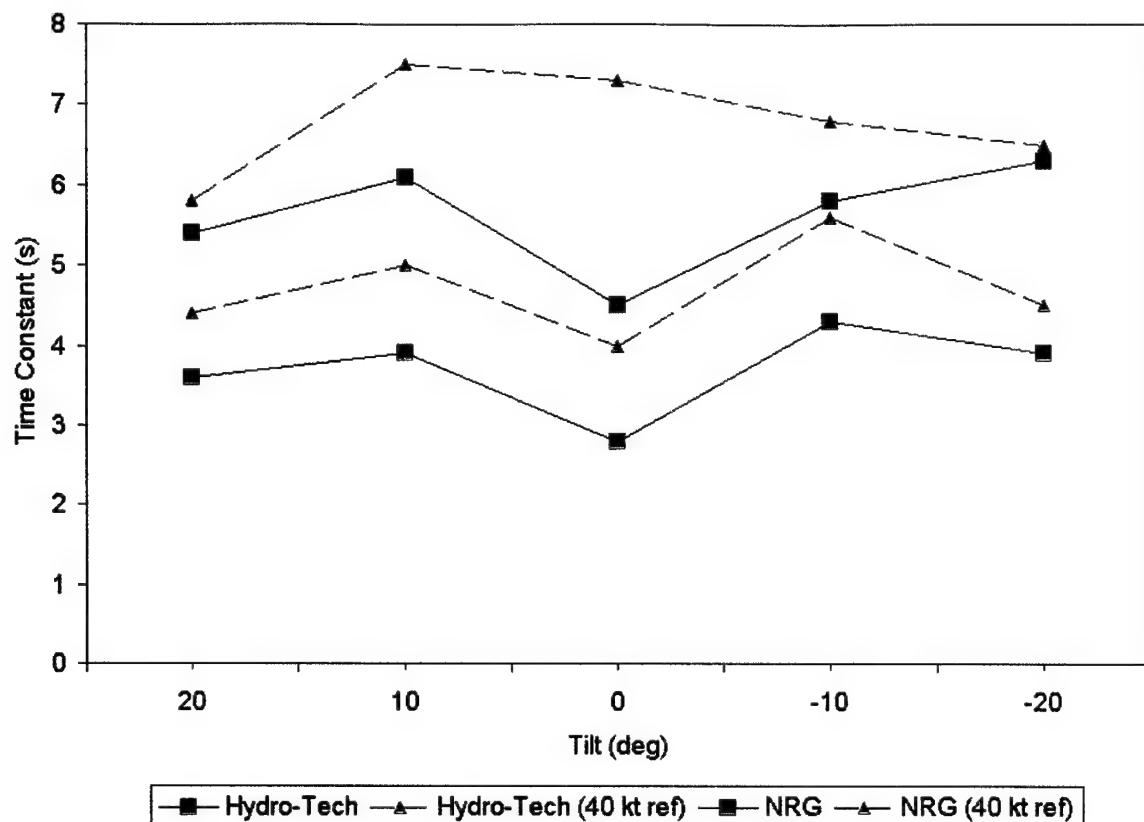
FIGURE 31. TIME CONSTANTS FOR HYDRO-TECH AND NRG WIND SENSORS AT VARIOUS TILTS

The time constants in the figure 31 show that the NRG sensor is more responsive than the Hydro-Tech sensor, and the relative response is slower for off-axis winds.

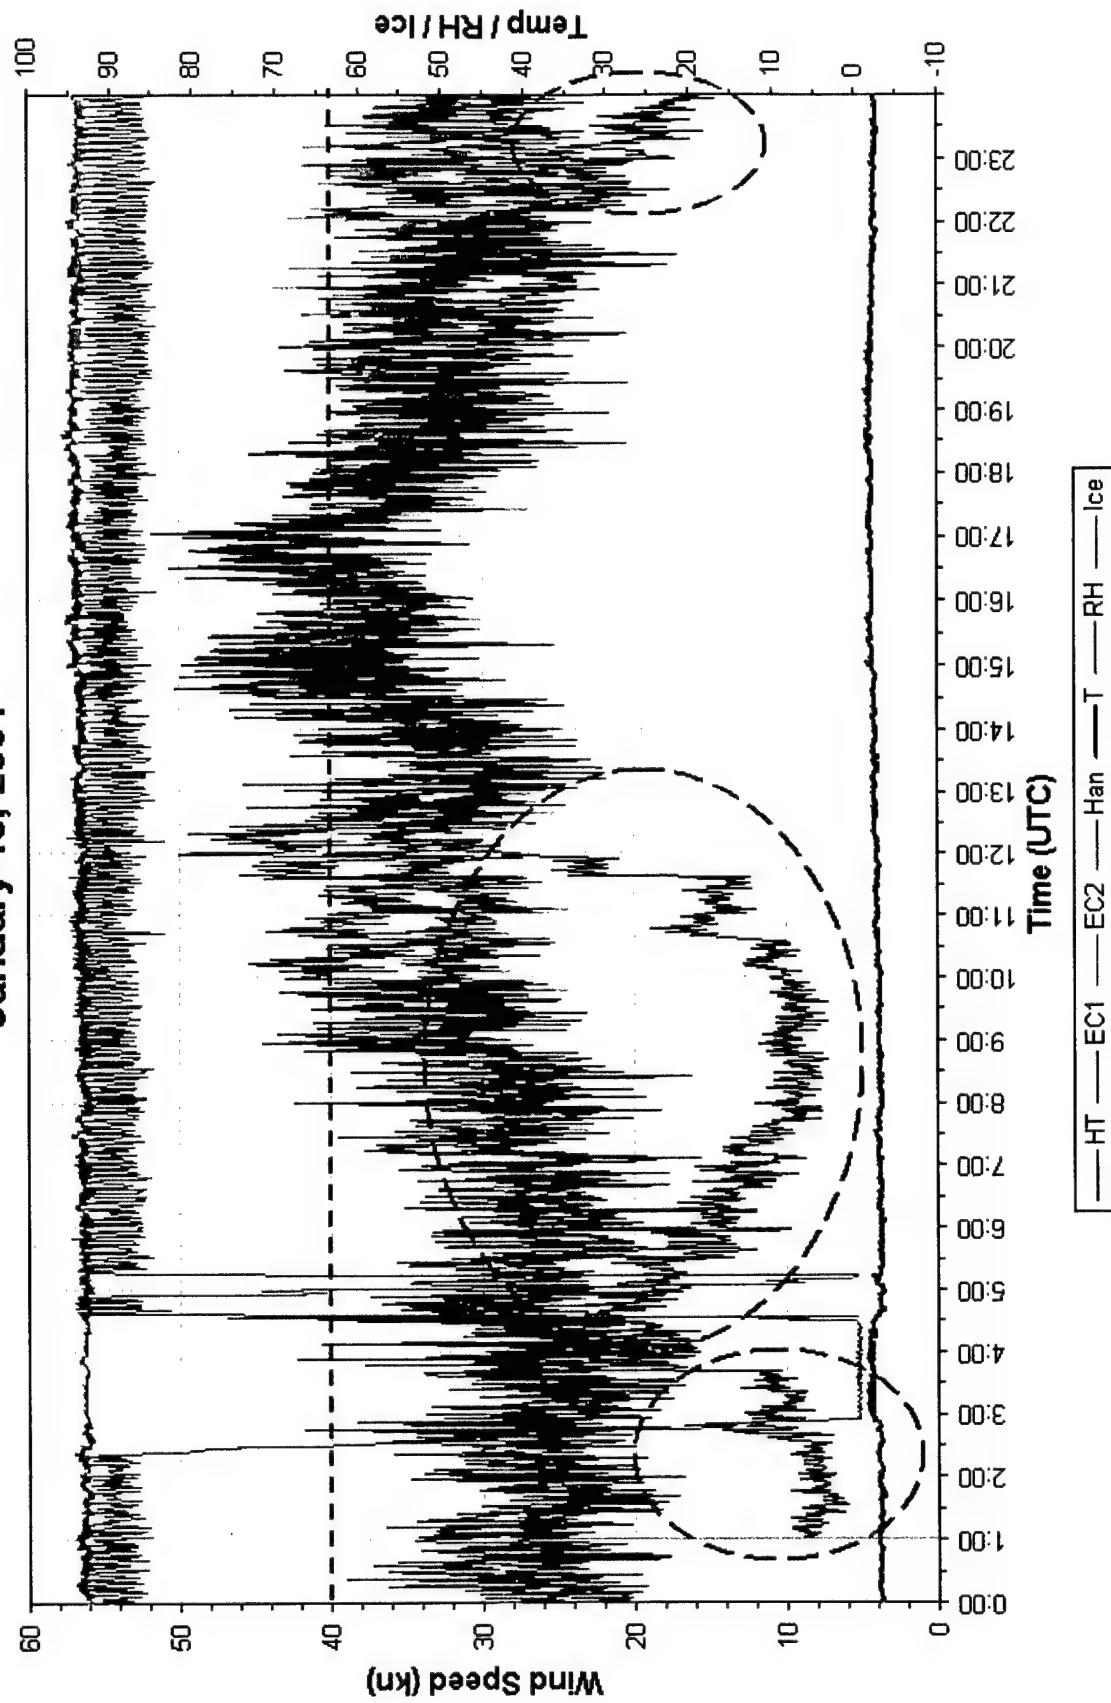
FIGURE 52. COMPARISON OF EC1 WIND SPEEDS DURING AN ICING EVENT

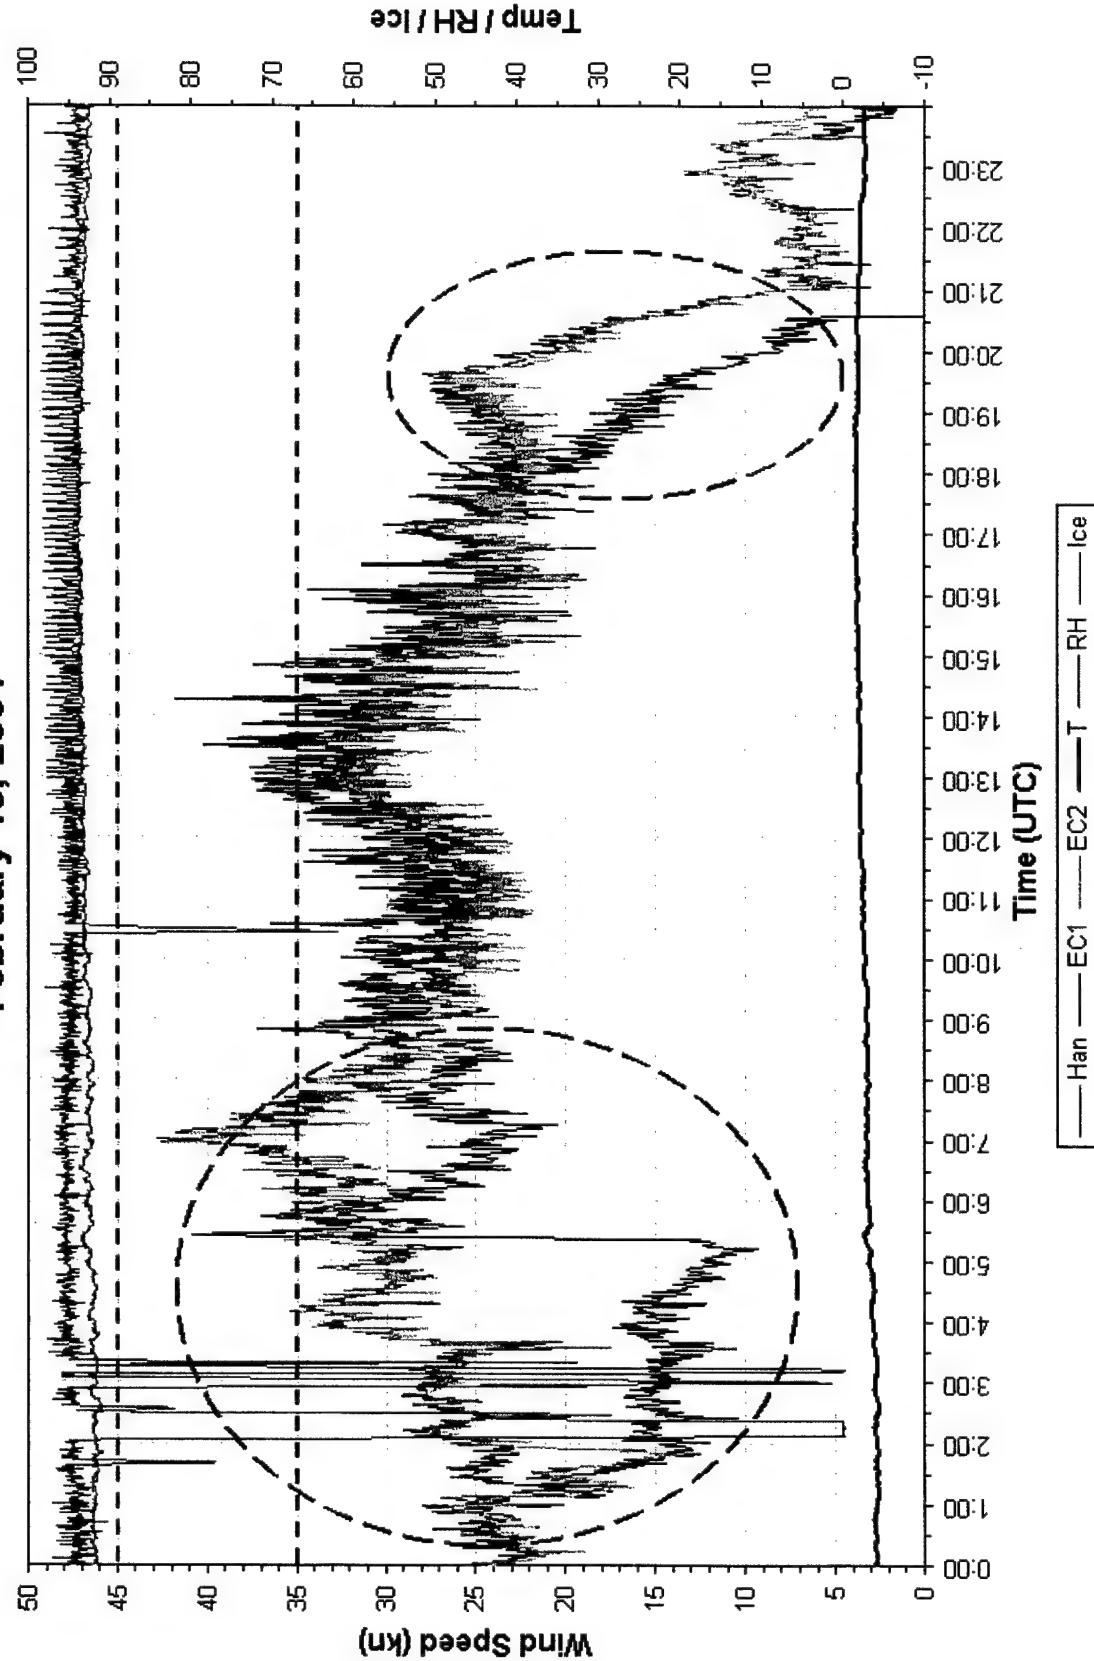
FIGURE 53. DEGRADED EC1 ROTOR PERFORMANCE DURING AN ICING EVENT

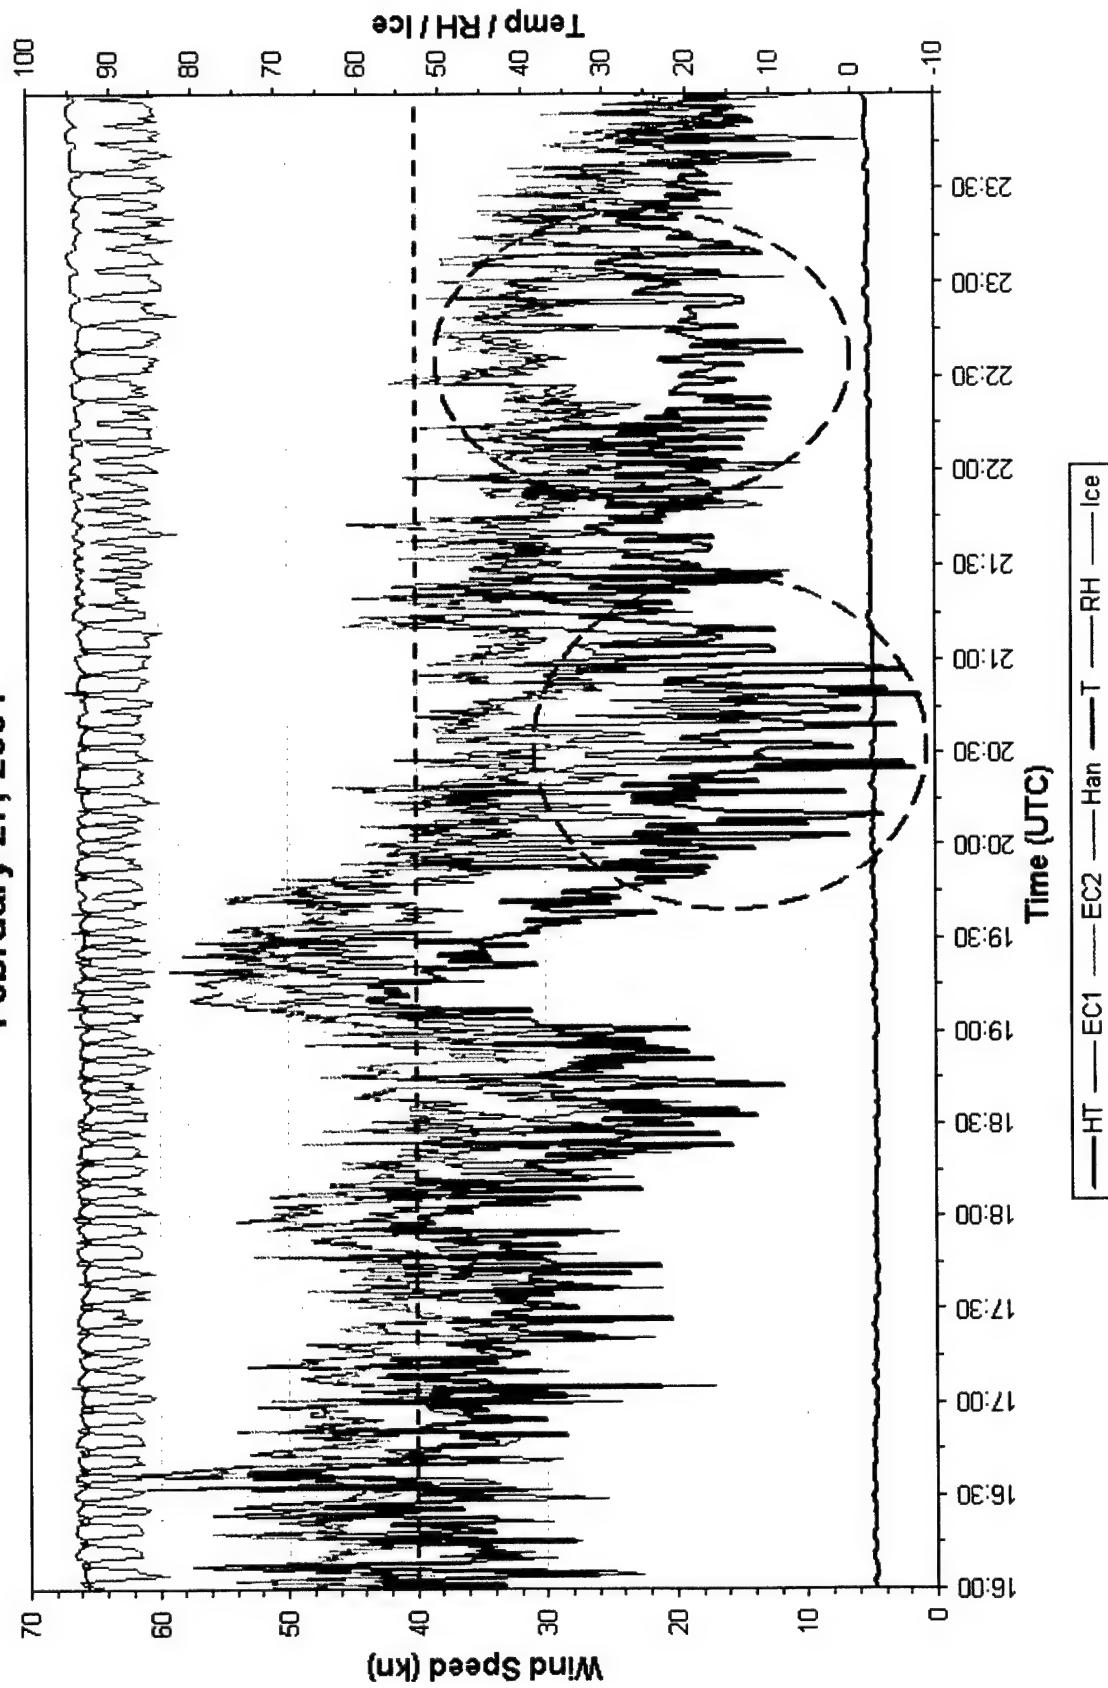
FIGURE 54. TEST HYDRO-TECH ROTOR FAILURE DURING AN ICING EVENT

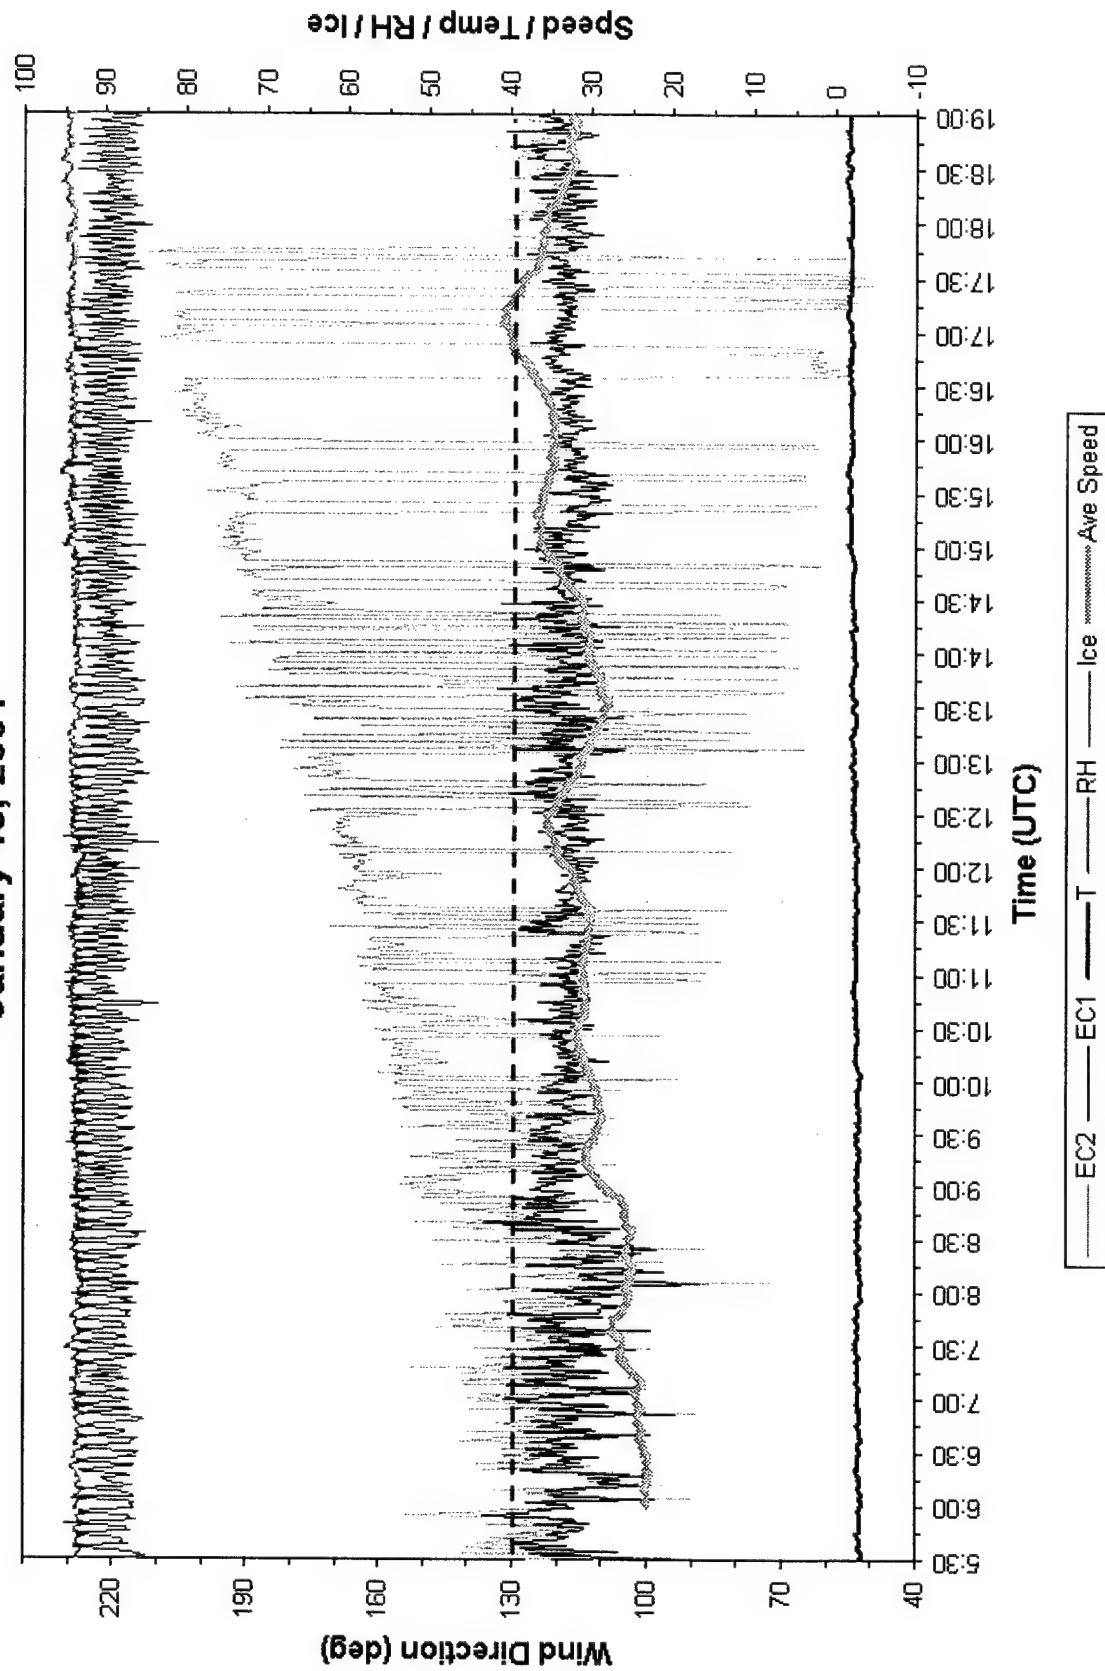
FIGURE 55. EC2 DIRECTION VANE FAILURE DURING AN ICING EVENT

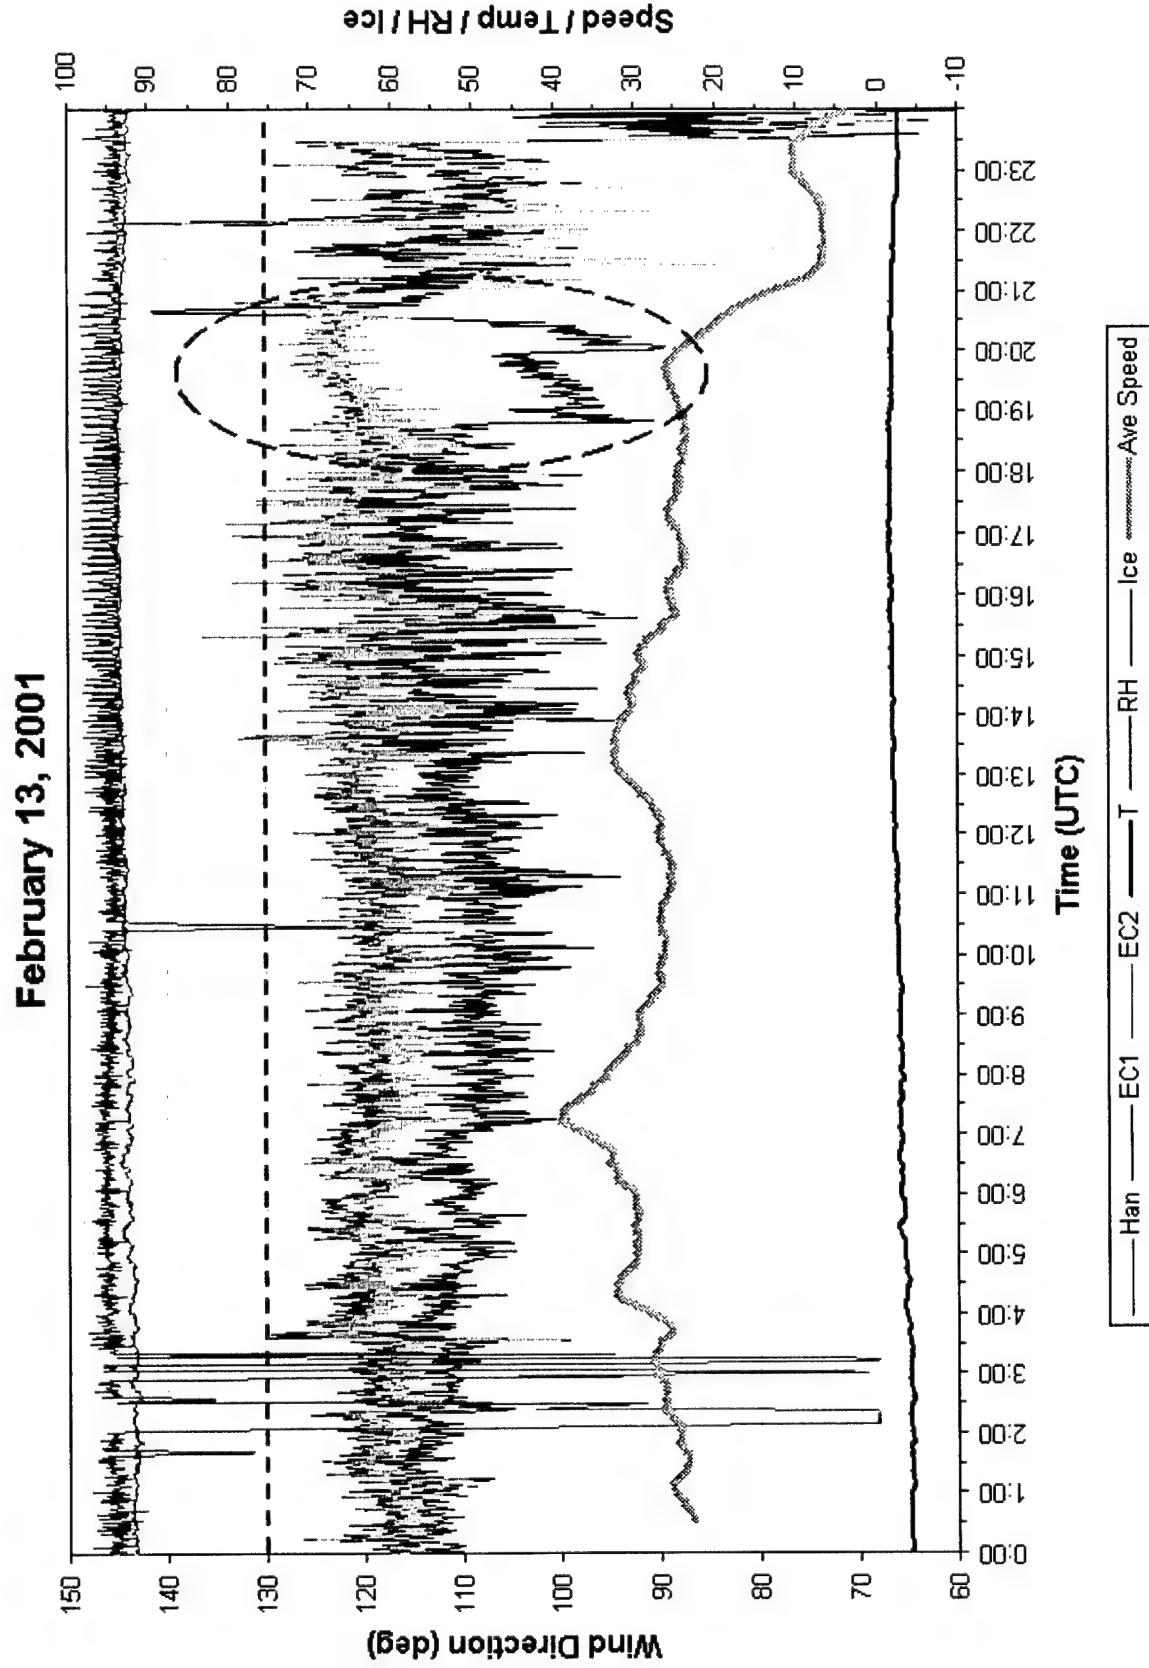
FIGURE 56. EC1 DIRECTION VANE FAILURE DURING AN ICING EVENT

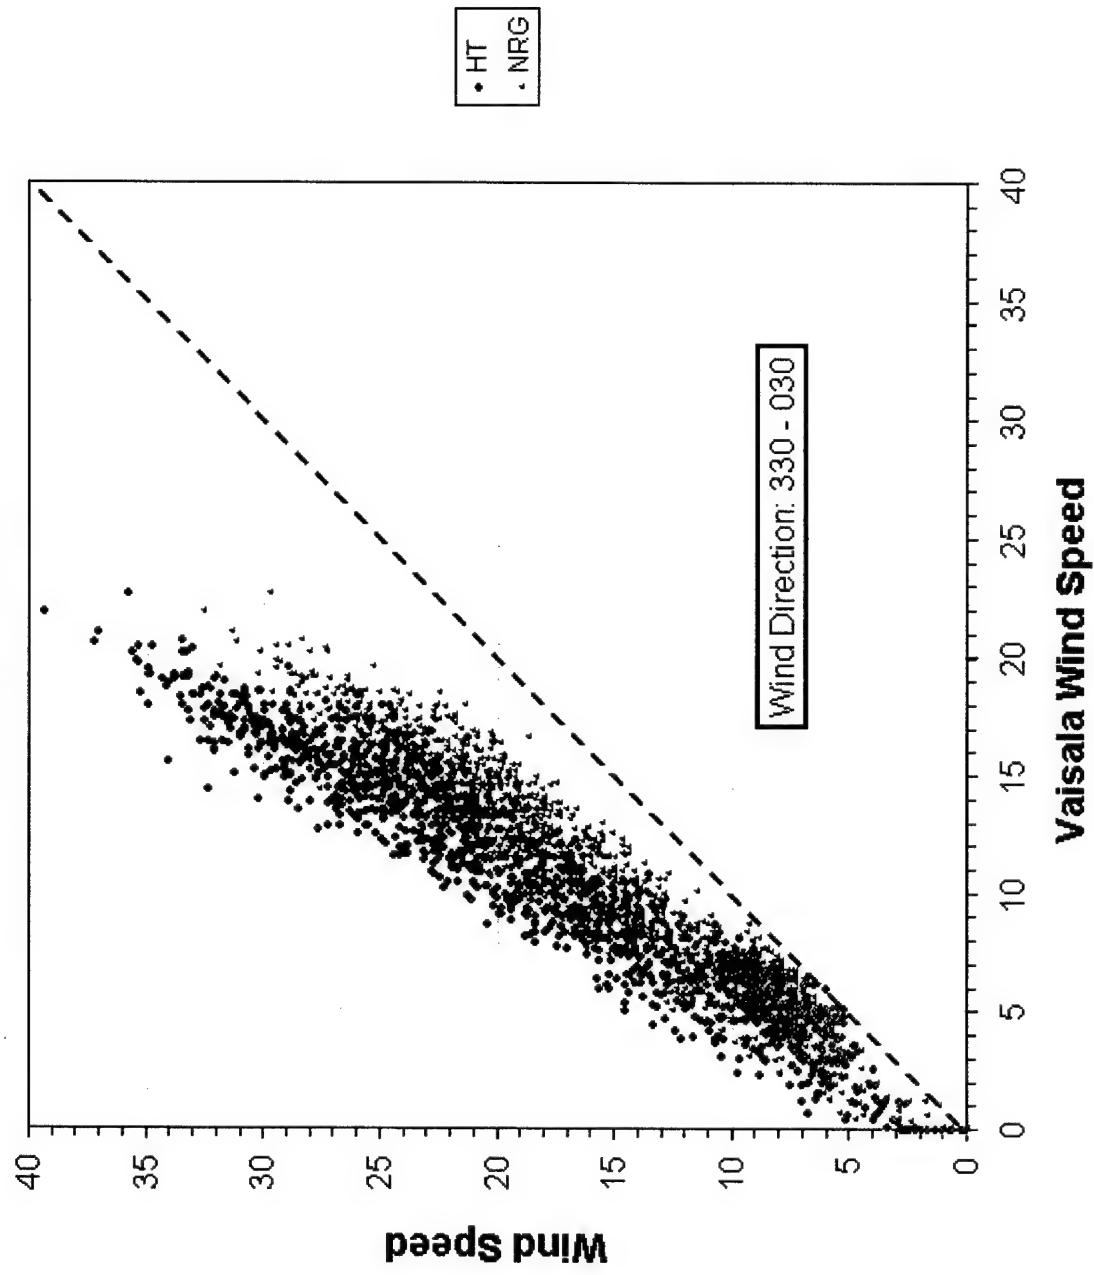
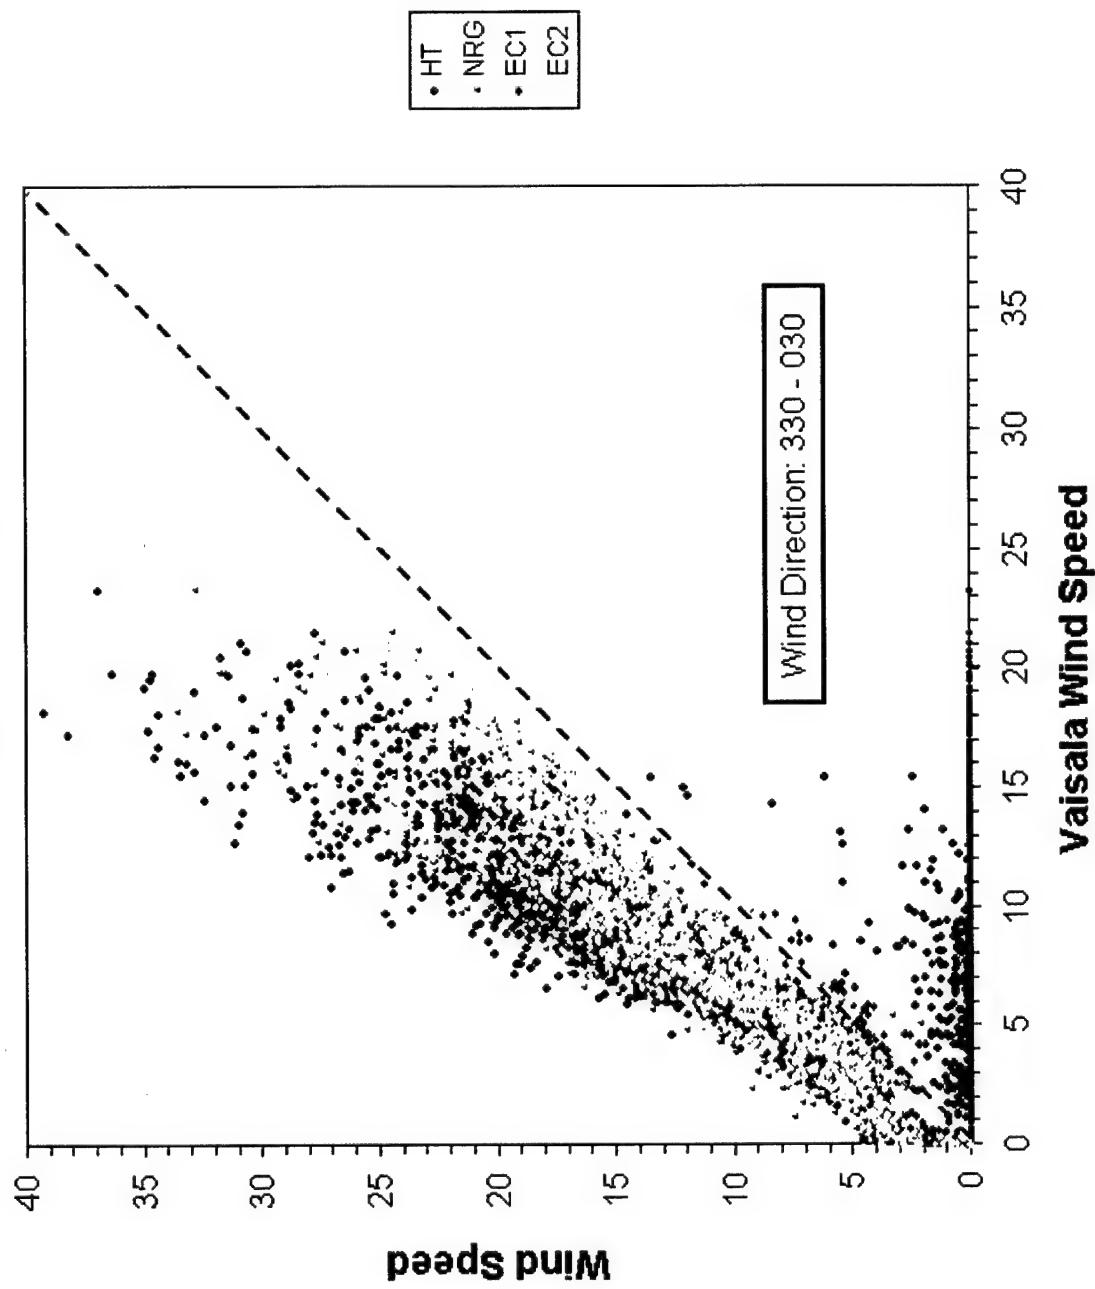
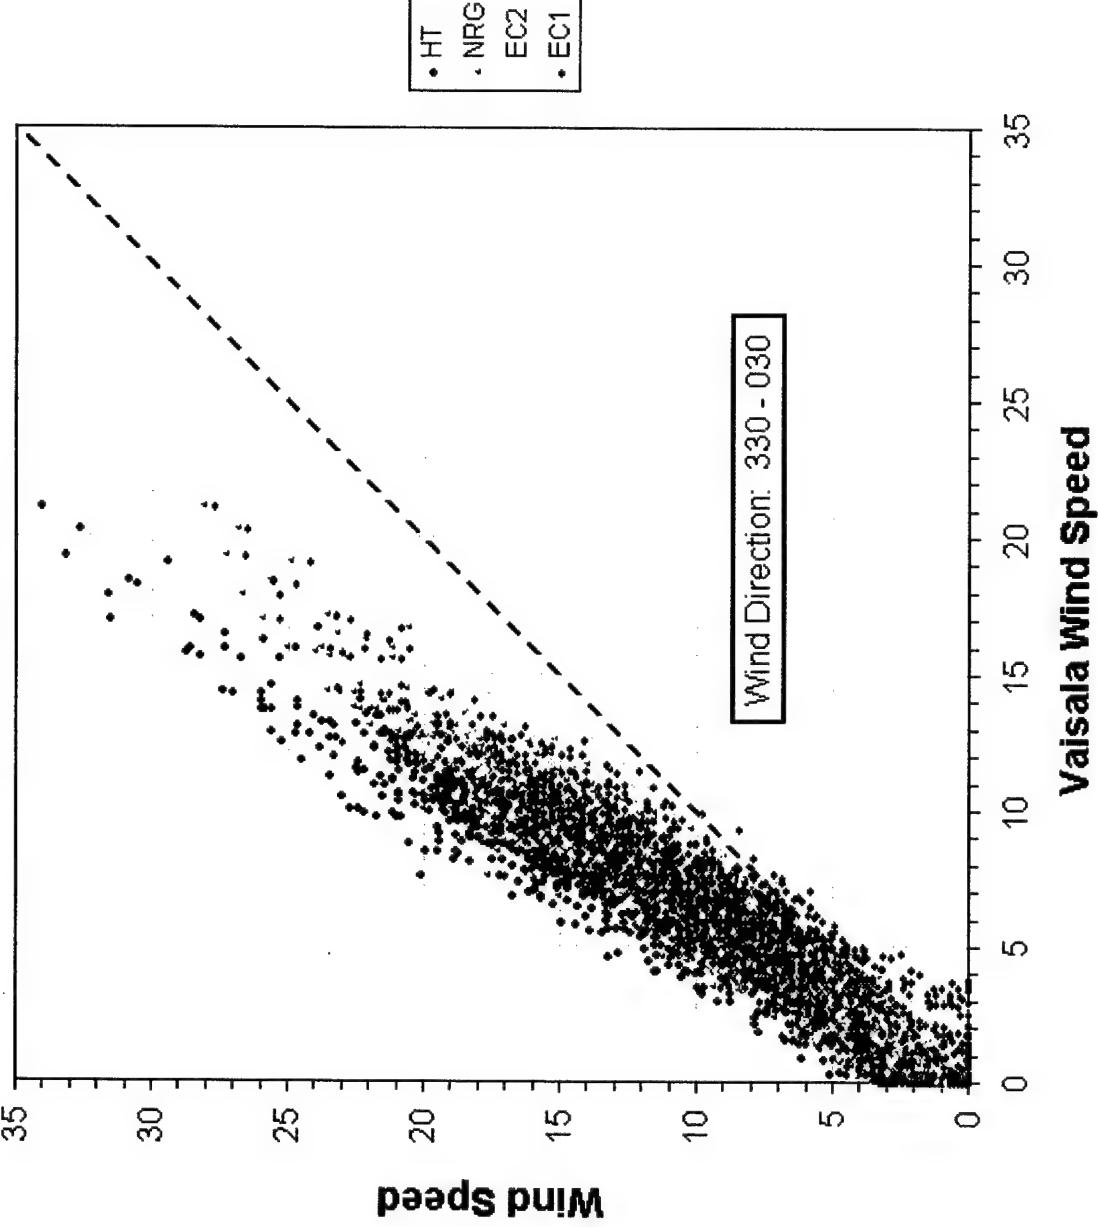
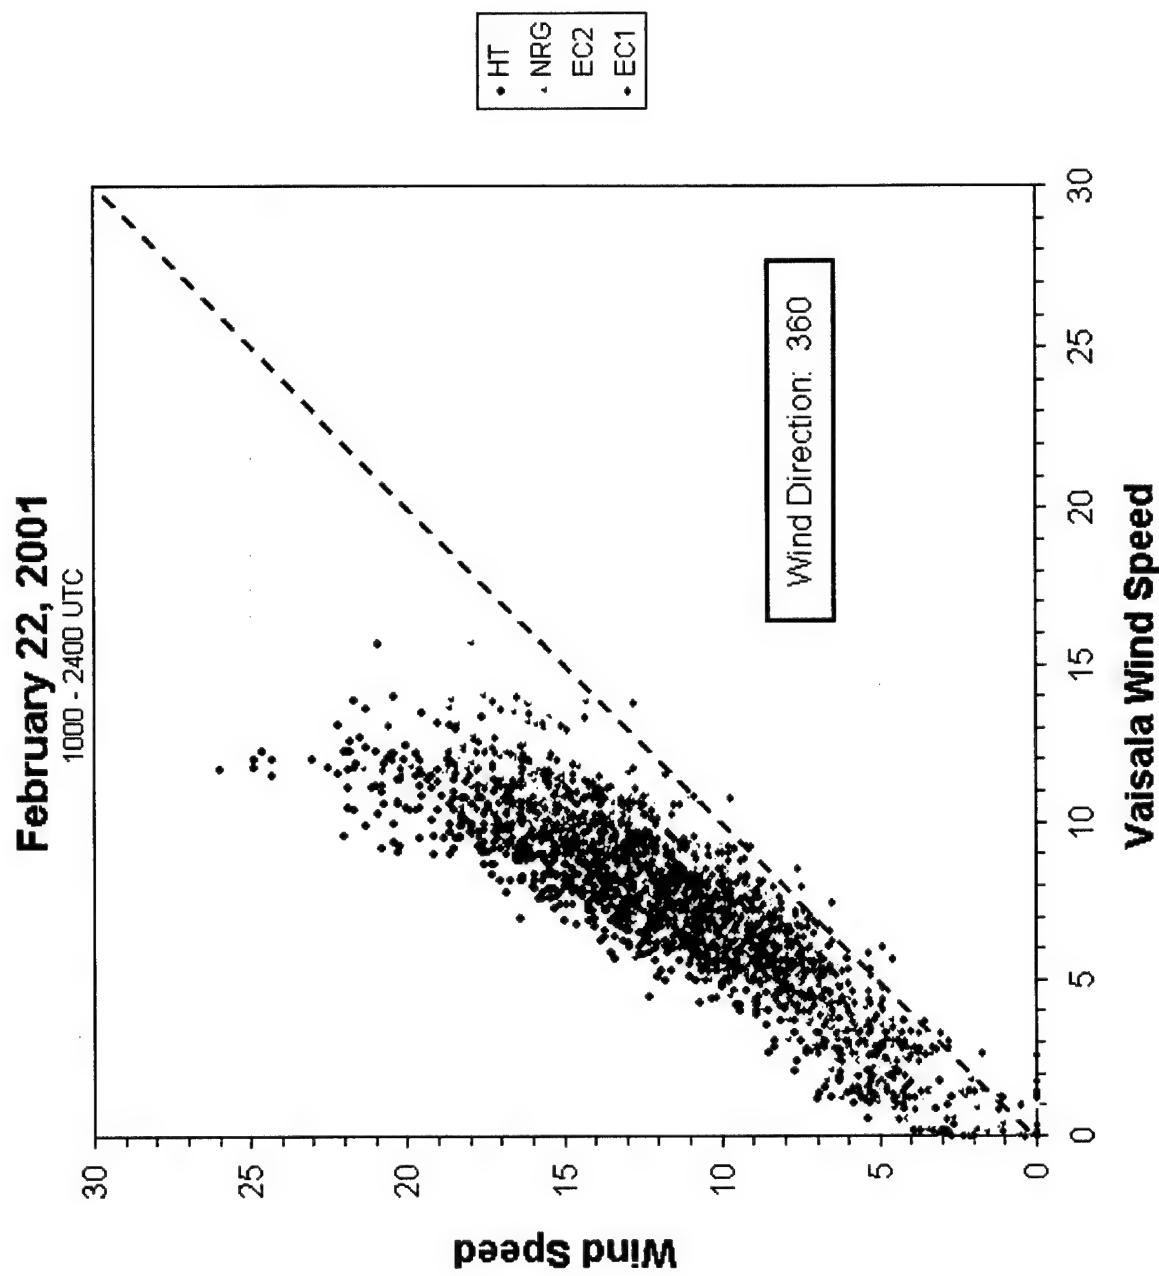
Performance of the sensor was found to be consistent with data from the wind tunnel tests and results from the MWO study. Typical cases showing a comparison of wind speed against the Vaisala anemometer is provided in figures 57 through 60. Due to the inertia of the ruggedized sensor, the observed overspeeding and a low starting threshold was expected. The overspeeding indicated in the figure is particularly pronounced for northerly winds and is possibly exacerbated by the upslope winds at Eagle Crest in this direction. The off-axis overspeed response inherent to the sensor was also noted in the wind tunnel tests.
